**LASER-INDUCED DAMAGE IN OPTICAL
MATERIALS**

Concetto R. Giuliano

Hughes Research Laboratories

**CONTRACT F19628-72-C-0348
PROJECT 2042
SEMIANNUAL TECHNICAL REPORT NO. 2**

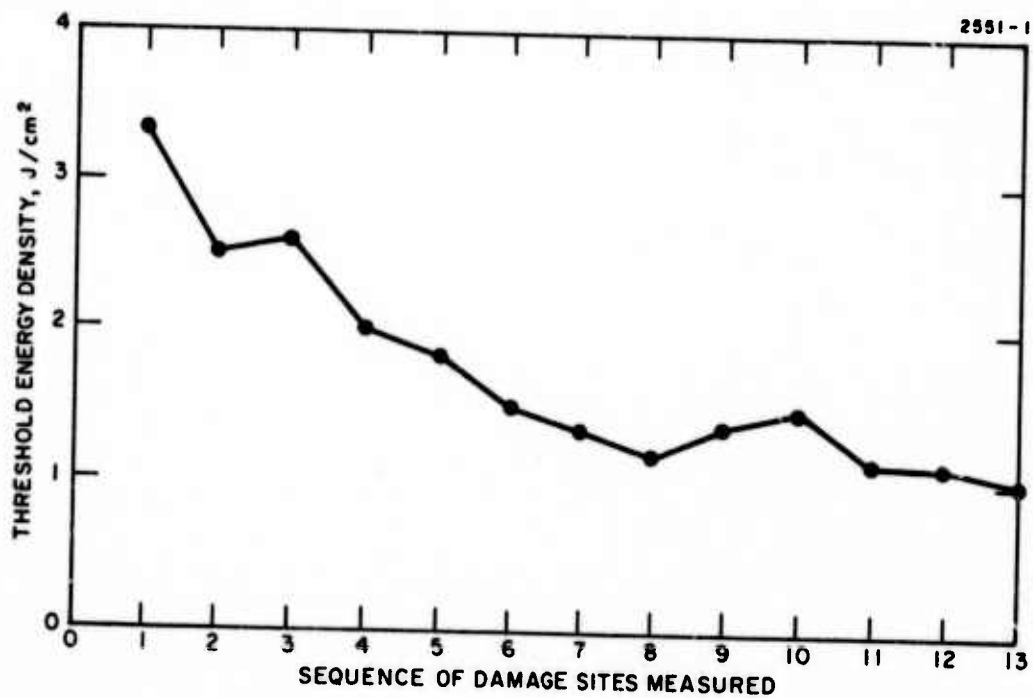
The threshold value reported in Table I is an average of all the thresholds measured. However, it can be seen (Fig. 1) that the first few points measured result in lifting the average considerably. The total sequence of measurements illustrated in Fig. 1 represent about 100 shots of the laser and required most of a full day to carry out. This kind of behavior illustrates the difficulty one faces in obtaining meaningful damage threshold data for proustite.

Fig. 1. Values of damage thresholds obtained in sequence on a freshly polished proustite surface.

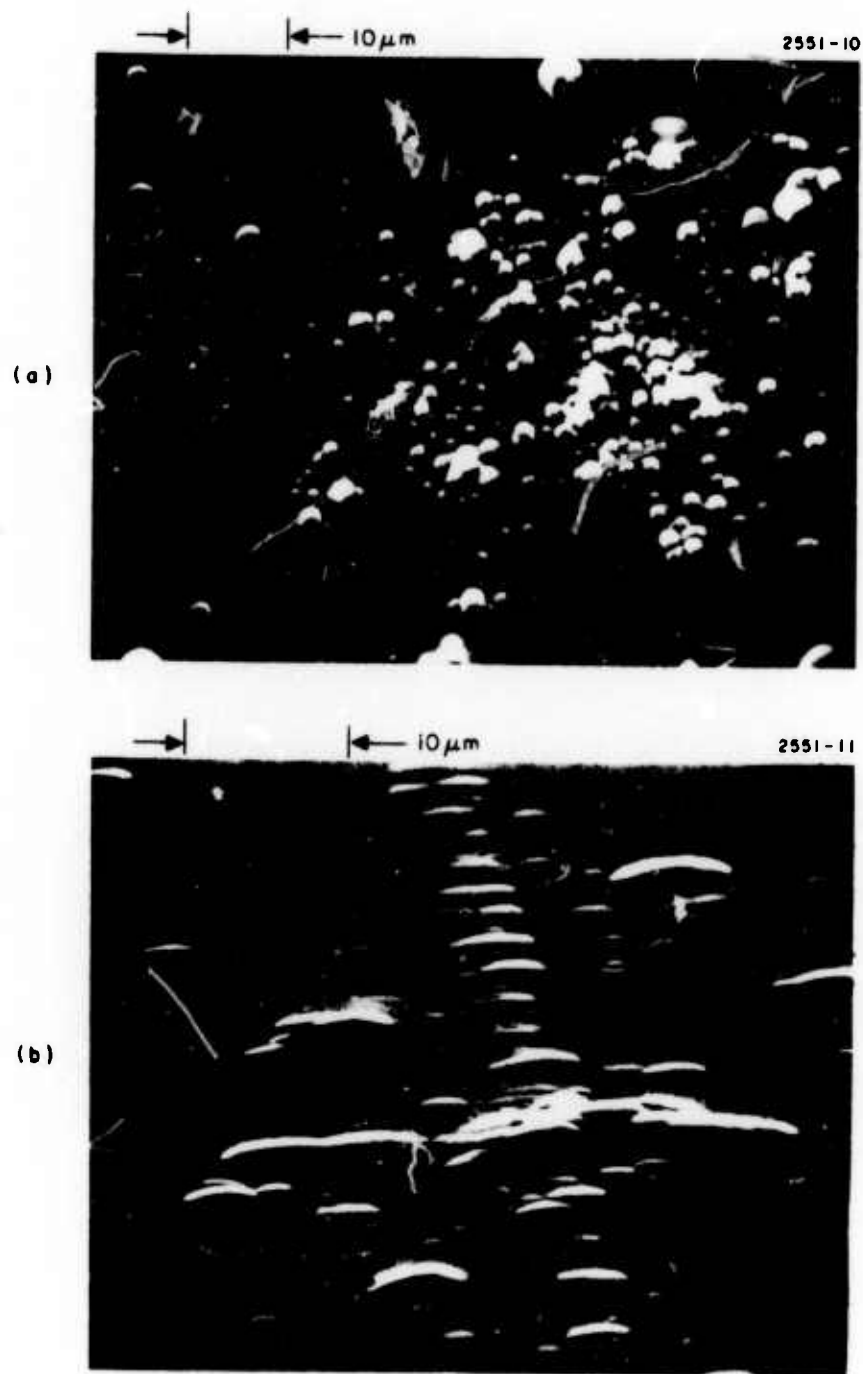
Thus we conclude that the samples of LiNbO_3 studied so far have a sufficiently high density of inclusions that essentially all the damage levels measured so far are not a measure of intrinsic material. Hence the possibility of improving the material quality via ion polishing is still an open one.

Fig. 4. Scanning electron micrographs of surface features on LiNbO_3 after ion beam polishing.

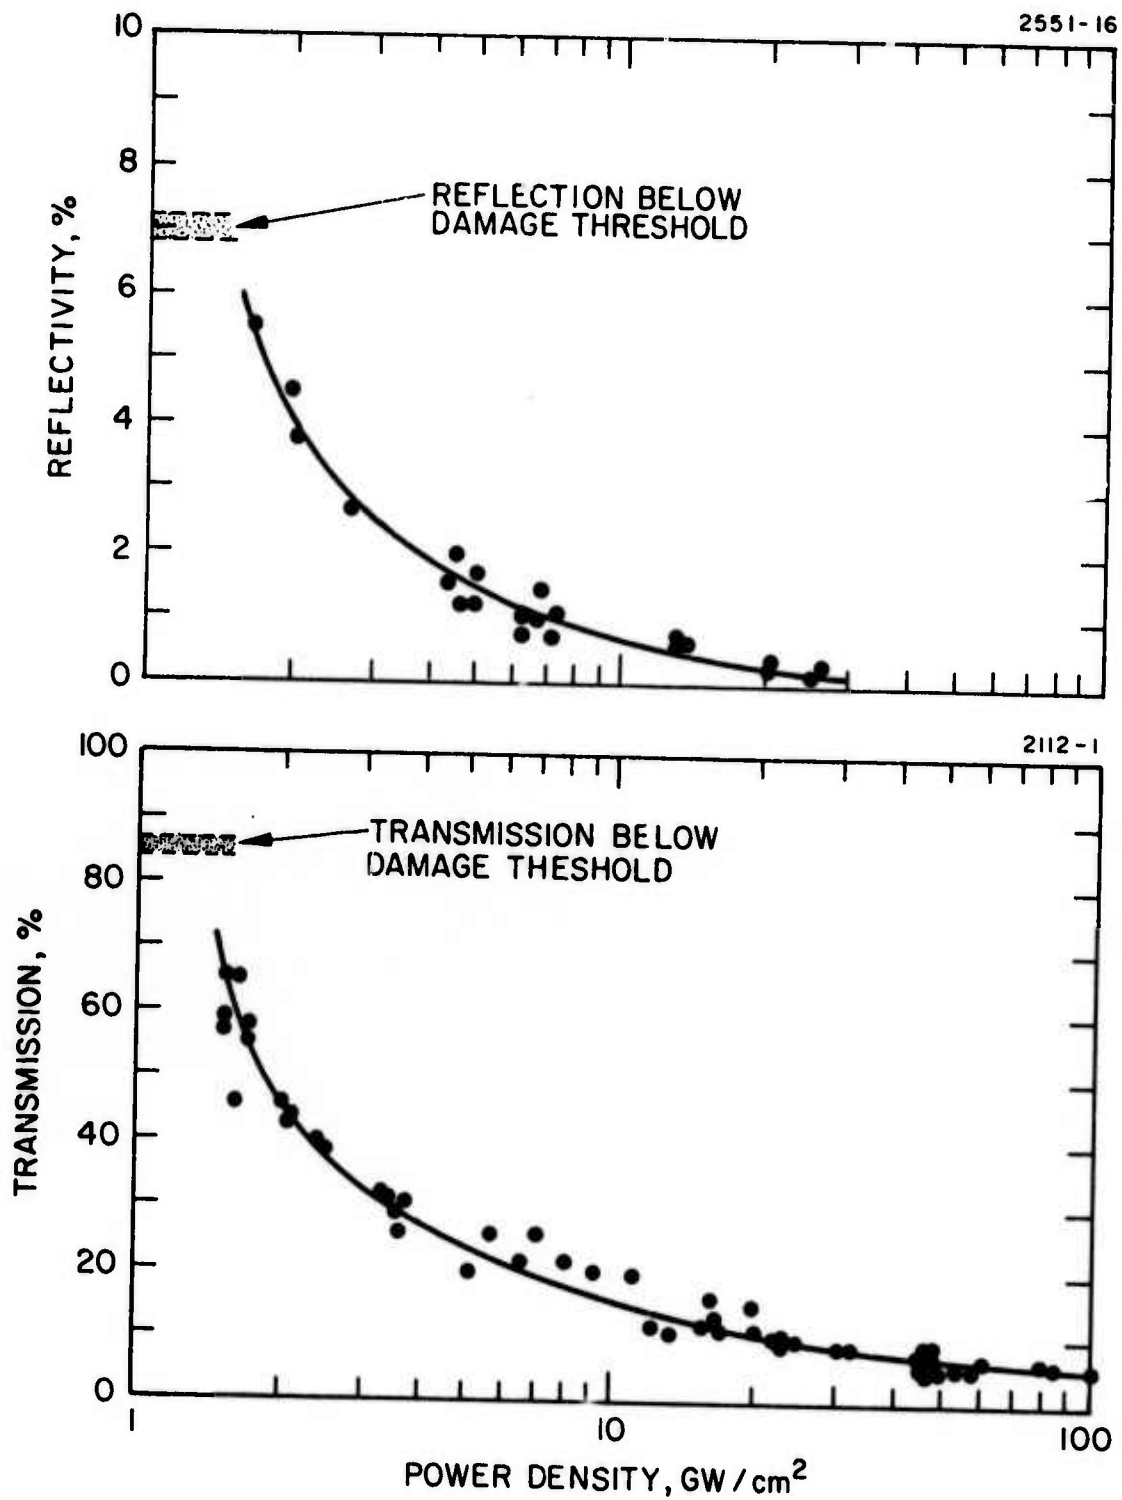
The percent transmission data that appeared in the last report are presented again for comparison with the reflectivity data. We see from these curves that both transmission and reflection show a monotonic decrease as the power increases above damage threshold.

Fig. 6. Integrated transmission and reflectivity of damaging laser pulses as a function of incident power on sapphire surfaces.

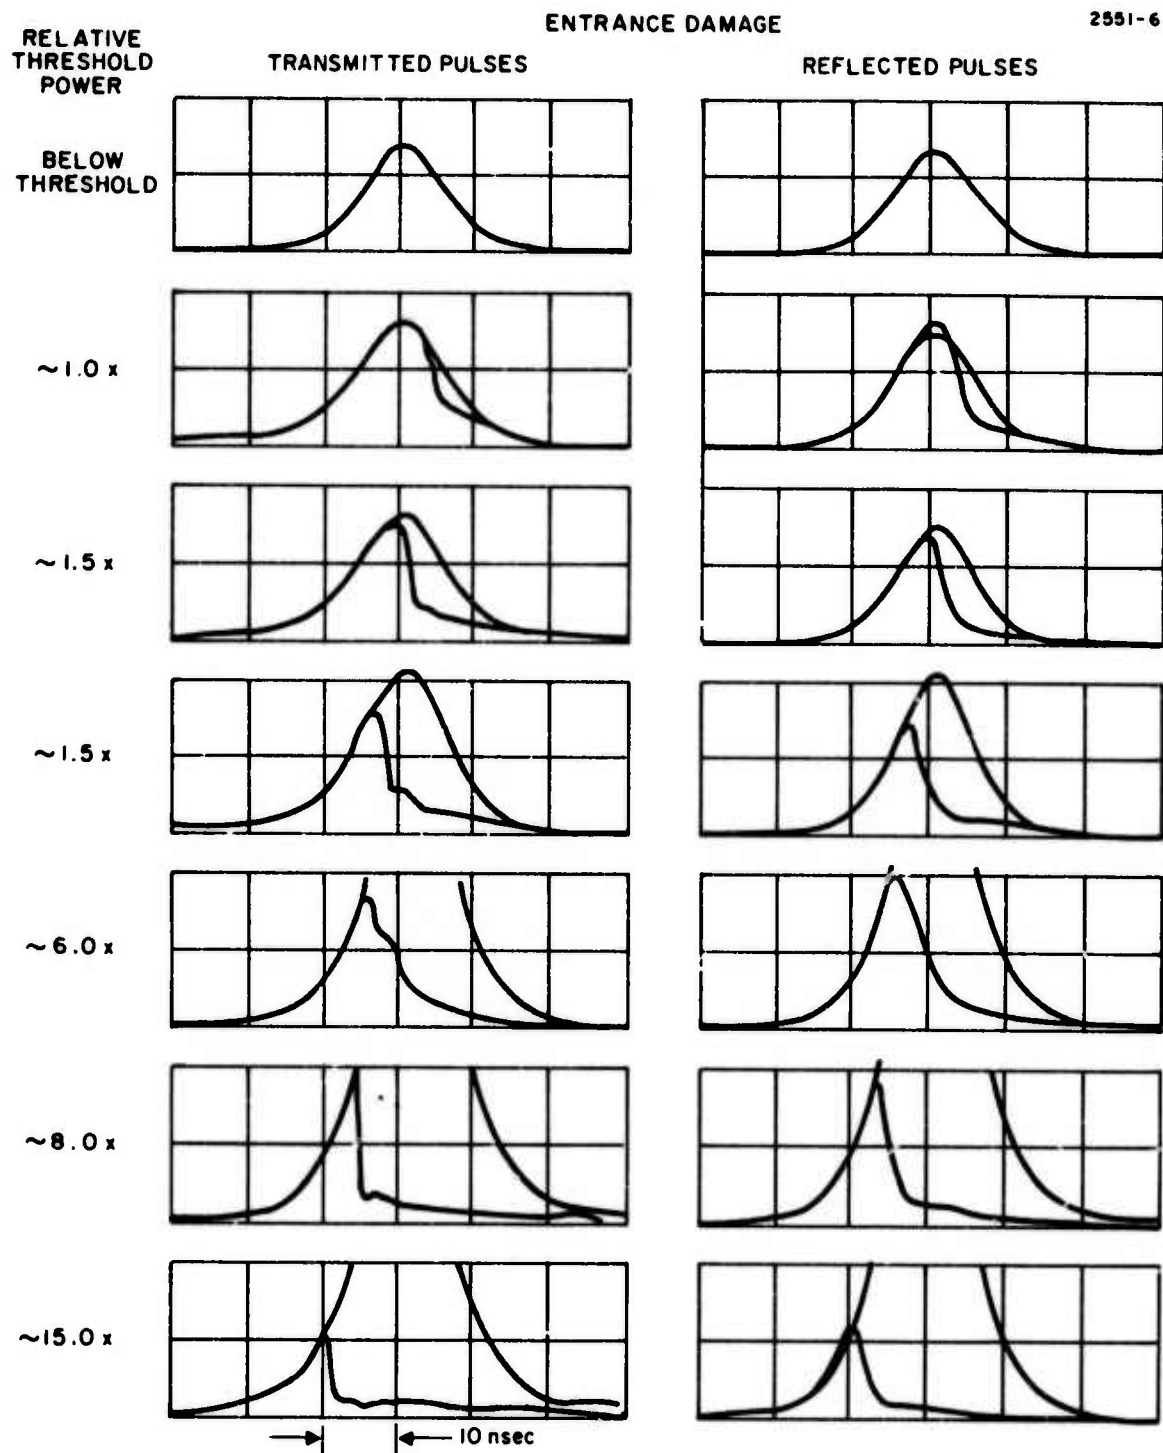
- The back-reflected pulse cuts off at the same time as the transmitted pulse.
- Most temporal irregularities in the transmitted pulse are duplicated in the reflected pulse.
- The back-reflected intensity for a damaging pulse is always less than or equal to that of the reference pulse. That is, the specular reflectivity of the interface during the occurrence of damage is always less than that of the undamaged interface.

Fig. 7. Temporal shapes of transmitted and reflected pulses for different powers relative to threshold for entrance damage.

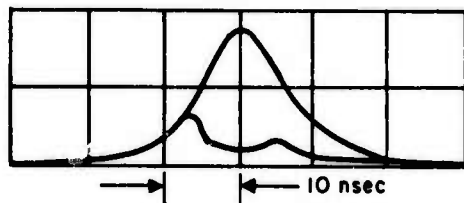
Fig. 8. Temporal shapes of transmitted and reflected pulses for different powers relative to threshold for exit damage.

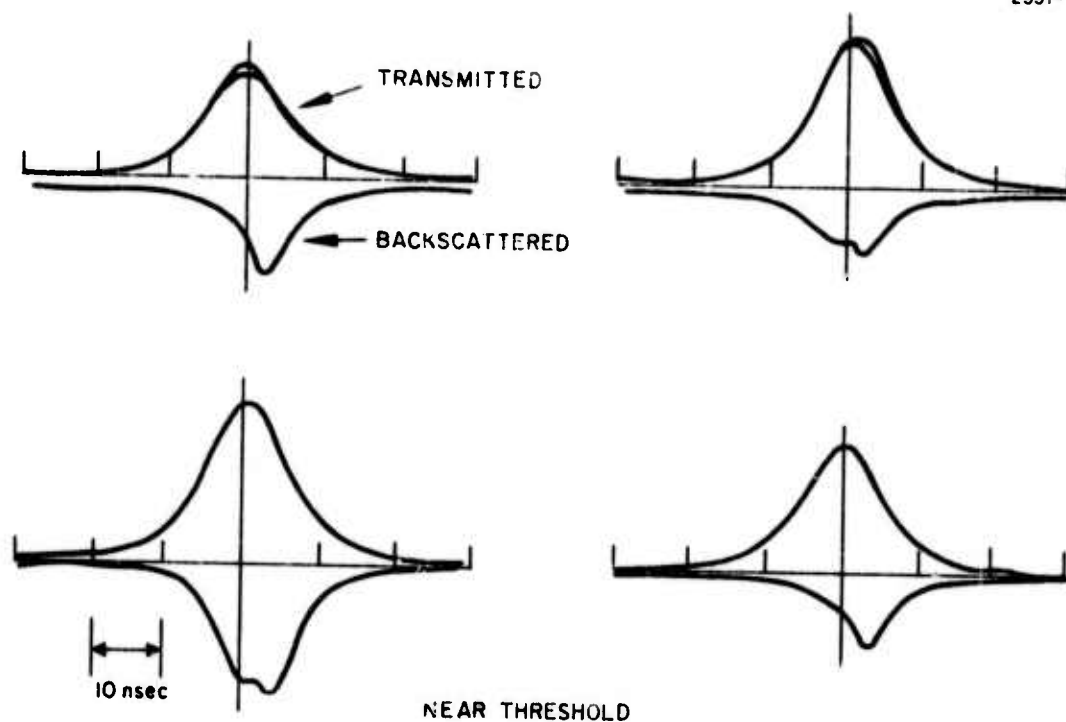
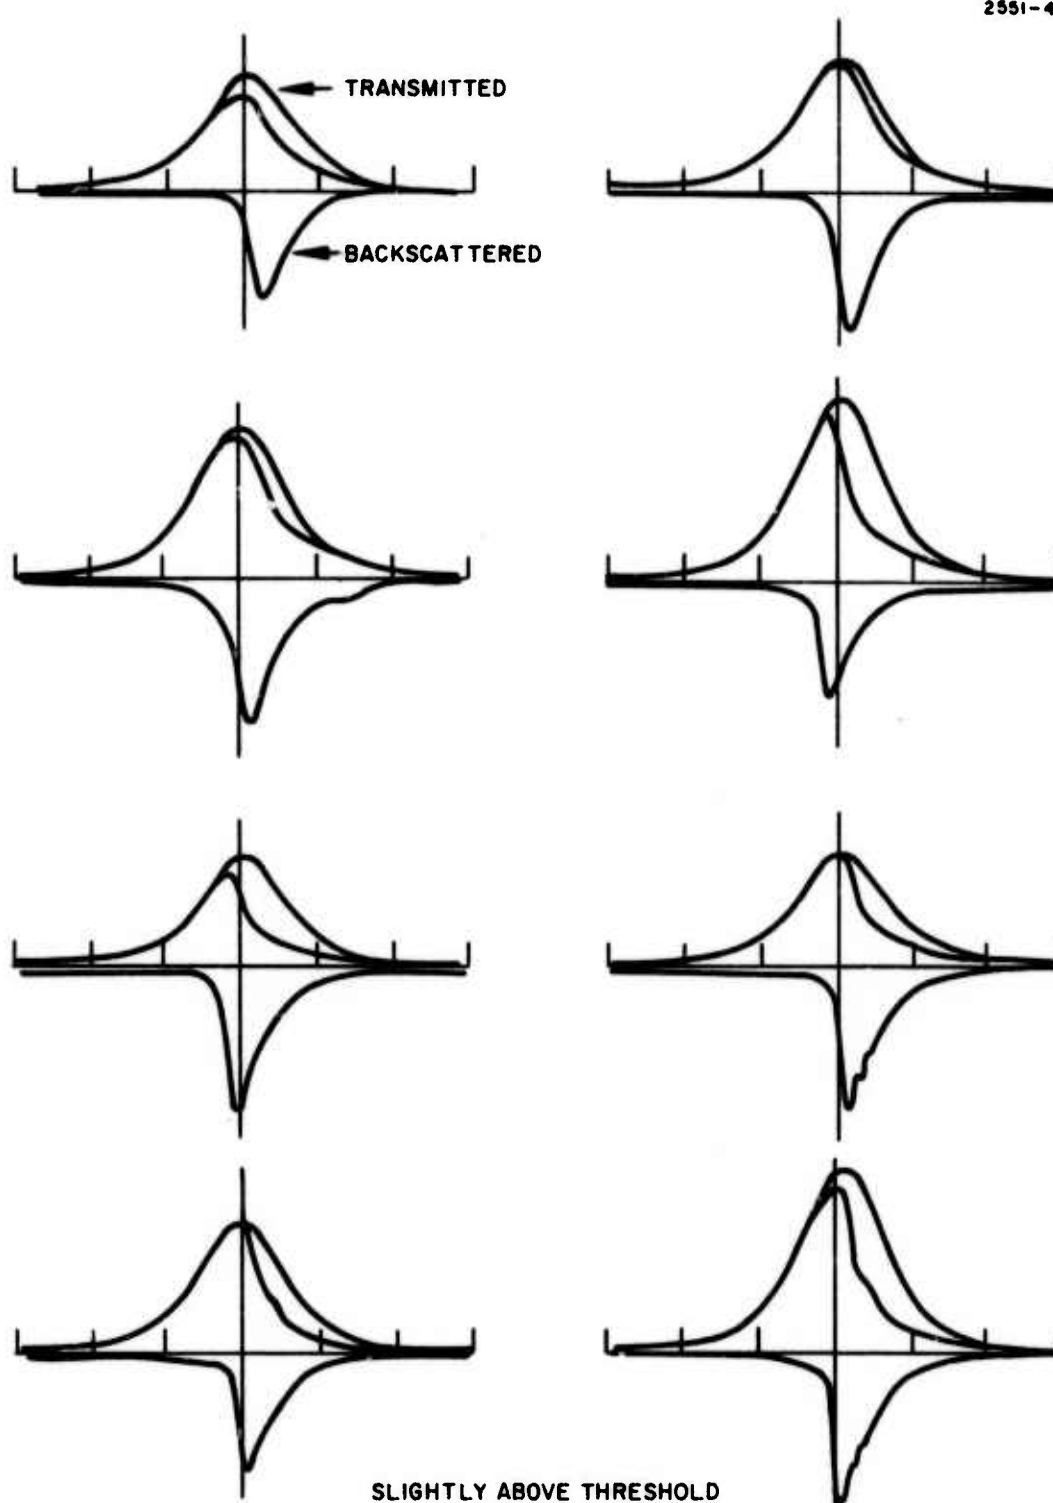
- The scattered light for damaging pulses is characterized by a sharply rising spike followed by a more slowly decaying tail.
- The peak of the scattered spike occurs at the same time that the transmitted pulse begins its sharp cutoff.
- The scattered intensity begins to rise from its background level before the transmitted pulse shows any appreciable irregularity.
- In cases where very slight damage occurs so that the transmitted pulse shows little or no temporal irregularity, there is still an appreciable temporal irregularity in the scattered light.

Fig. 10(a). Temporal profiles of laser pulses transmitted through and backscattered by sapphire samples at different powers relative to entrance surface damage threshold.

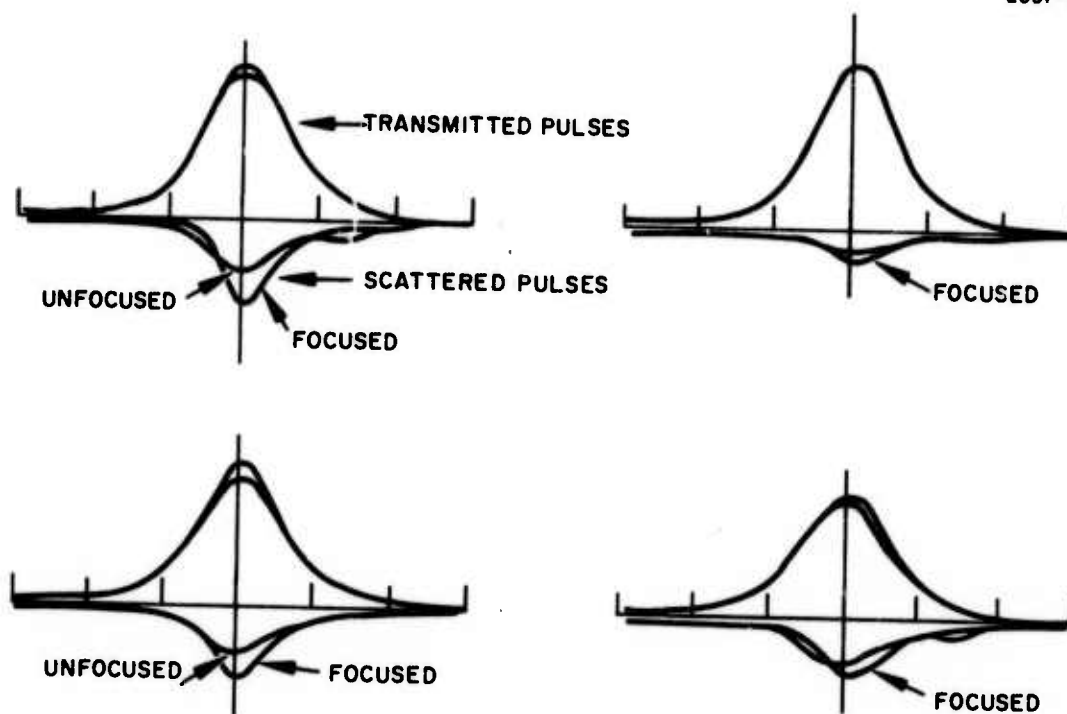
Fig. 11. Backscattered pulses compared with transmitted pulses below damage threshold showing temporal irregularities in the backscattered pulse.

A possible explanation is a precatastrophic surface phenomenon such as a slight local heating resulting in an effective local curvature at the surface that could deflect the beam temporarily off axis. Another is the production of a microscopic plasma that is not visually detectable but that results in a subtle off axis backscattered component.

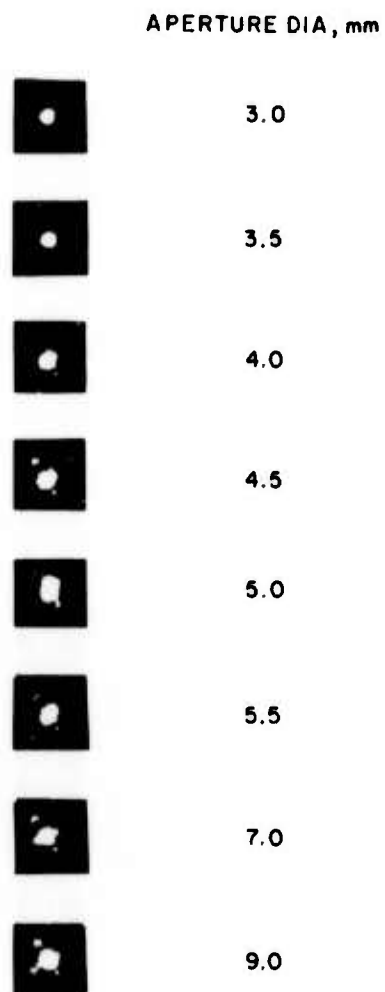
Qualitative features of these beam profiles are shown in Figs. 13 and 14. At low powers a smooth circular spot is seen that remains essentially unchanged when damage threshold is reached and even substantially above damage threshold ($\sim 2x$). At higher powers (above twice threshold) signs of off-axis features begin to appear and an increasing amount of light is detected in the form of irregular rings and bright spots.

Fig. 14.
Photographs of back-reflected beam for different aperture sizes between lens and sample. Constant laser power for each shot $\sim 10\times$ threshold.
